NATIONAL TRANSPORTATION SAFETY BOARD

ON-SCENE and EXAMINATION INFORMATION

**NTSB Accident: WPR17FA013
Accident Date: October 25, 2016**

Location: Pittsburg, California
Date: October 25, 2016
Aircraft: Beechcraft A36 'Bonanza', N364RM, Serial # E-2957
NTSB IIC: Michael Huhn

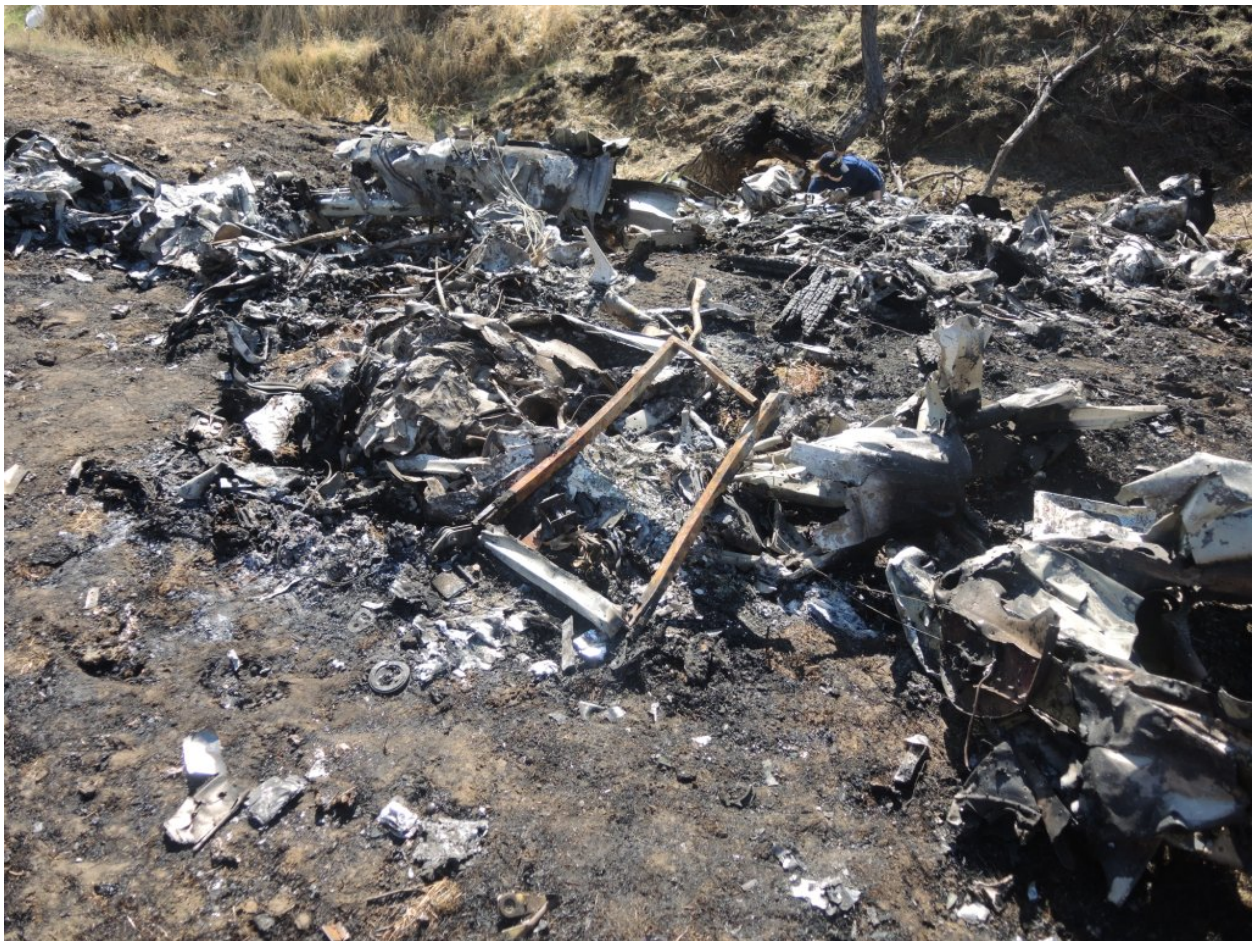
Figure 10 - Main Wreckage Close-Up

Due to the extensive impact and thermal damage, combined with the accident site topography, only limited examination of the wreckage was able to be accomplished on scene. The main wreckage was consistent with the airplane coming to rest inverted. During the recovery process, the wreckage 'layers' and components were examined, photographed, and segregated for post recovery examination. During the recovery, substantial efforts were made to ascertain flight control system continuity and integrity.

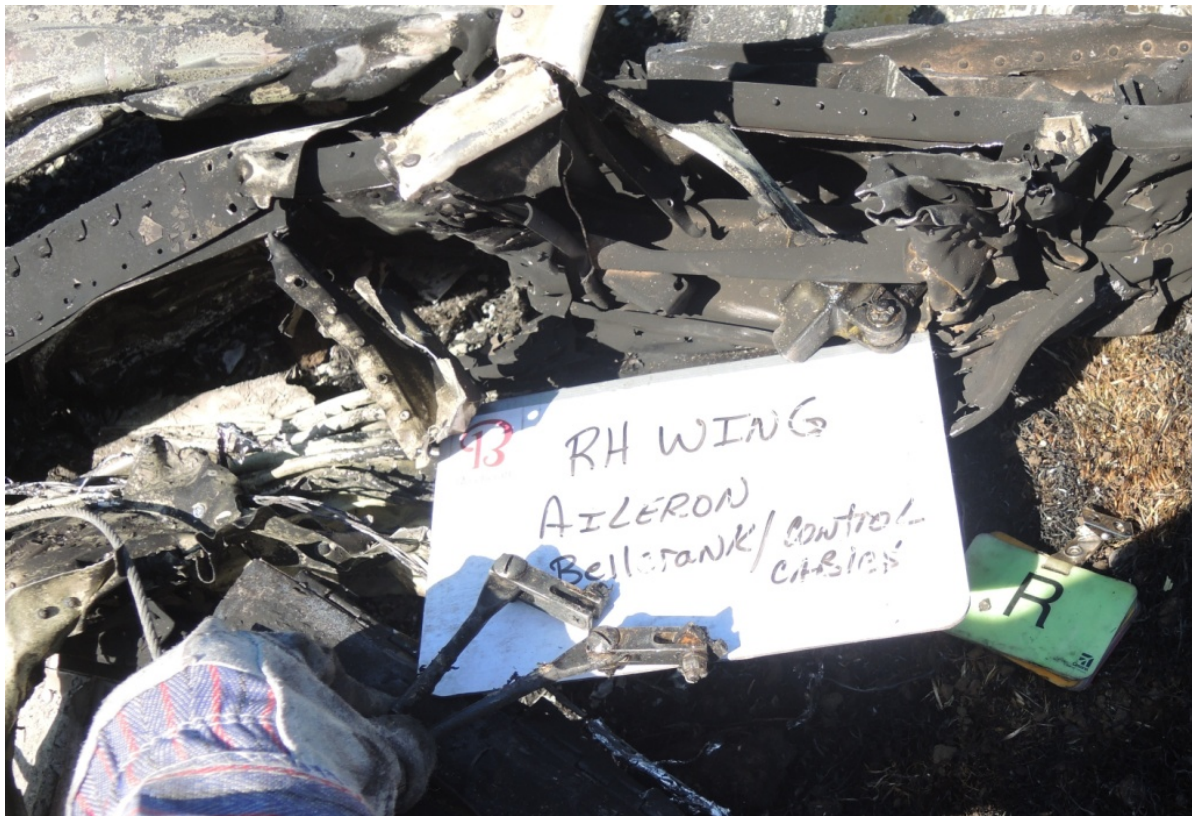
Figure 18 - Right Aileron Bellcrank

The left aileron remained attached to the left wing, but exhibited crushing, tearing, and thermal damage. The right aileron was fracture-separated from the right wing and exhibited crushing and tearing damage. The right aileron fragments were found in the debris field between the powerlines and the impact site, and exhibited no thermal damage. The aileron trim actuator (installed left side only) extension was measured to be 1 5/8 inches, which equates to about 4° left aileron TED.

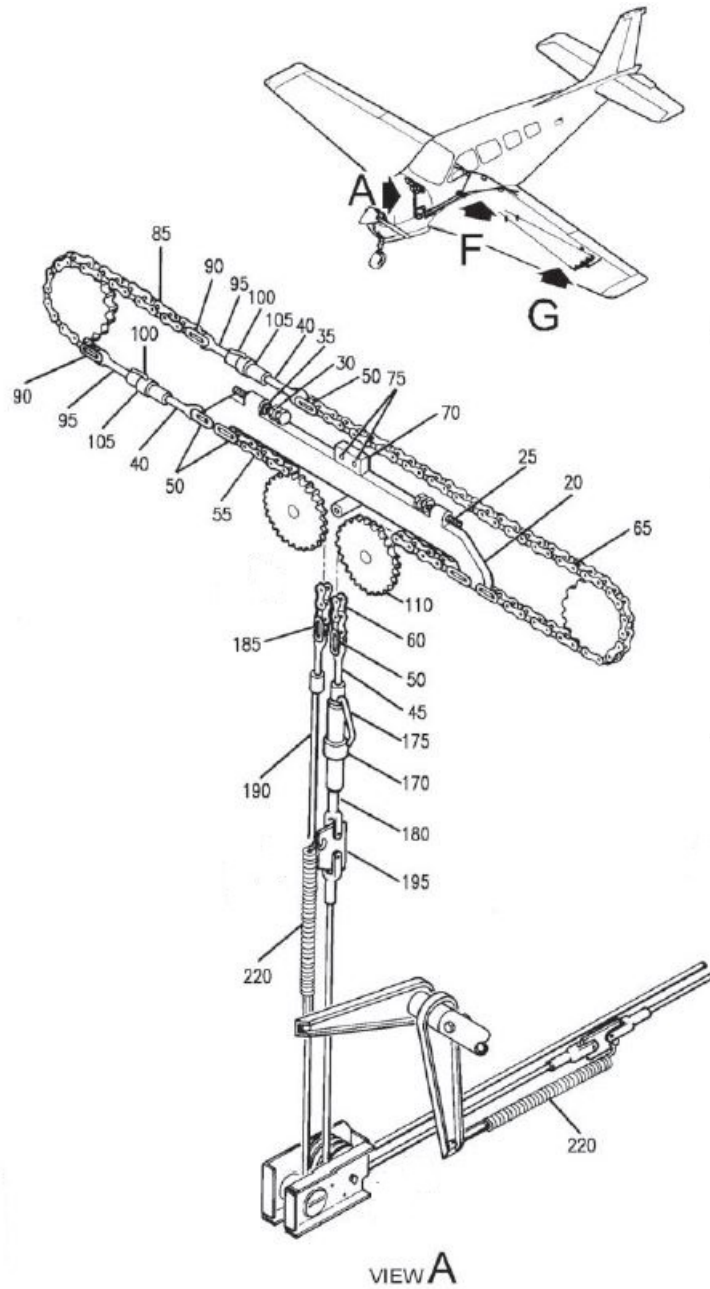
Figure 21 - Aileron Cockpit Linkage

- One aileron drive cable was fracture separated (consistent with tensile overload) near the cockpit area.
- A cable consistent with the aileron balance cable was identified. It was fracture-separated at about the mid-cabin location. The separation end fractures were consistent with tensile overload

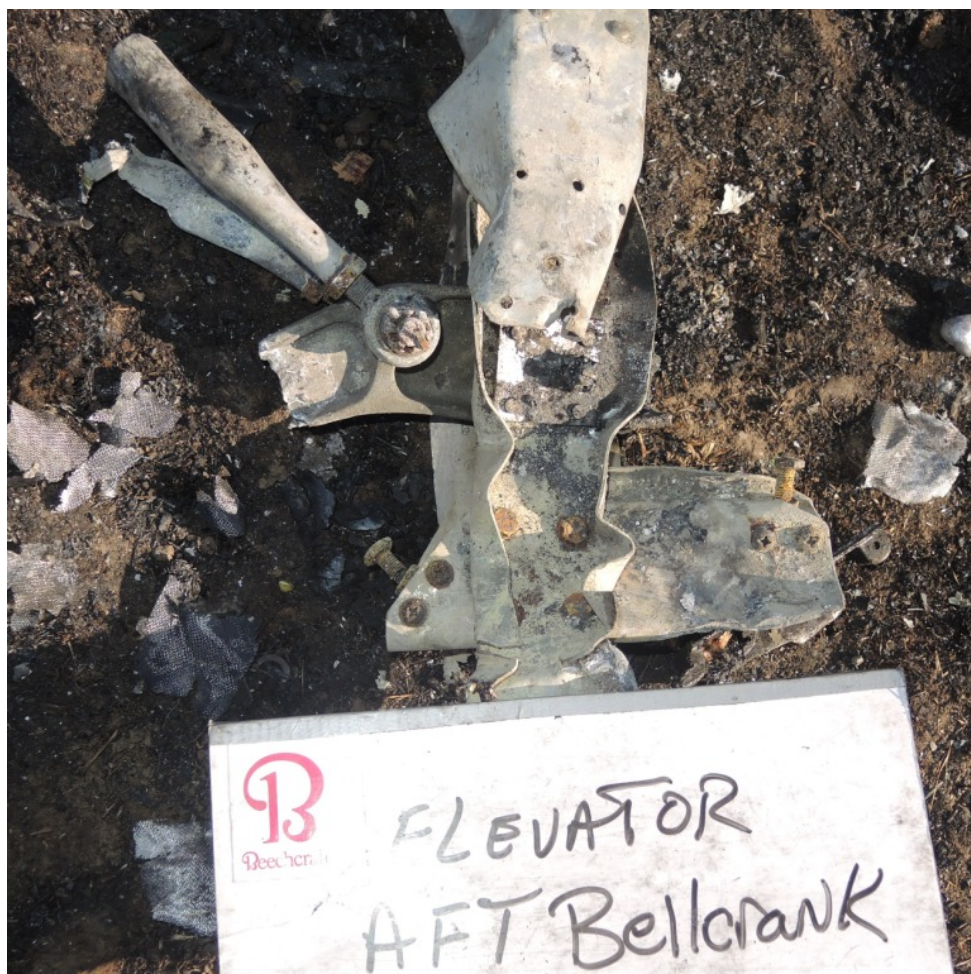
Figure 25 - Aft Elevator Bellcrank

- Two cables consistent with the elevator cables were observed to run from the elevator aft bellcrank to the cockpit area
- Two cables consistent with the rudder drive cables were observed to run from the rudder aft bellcrank to the cockpit area

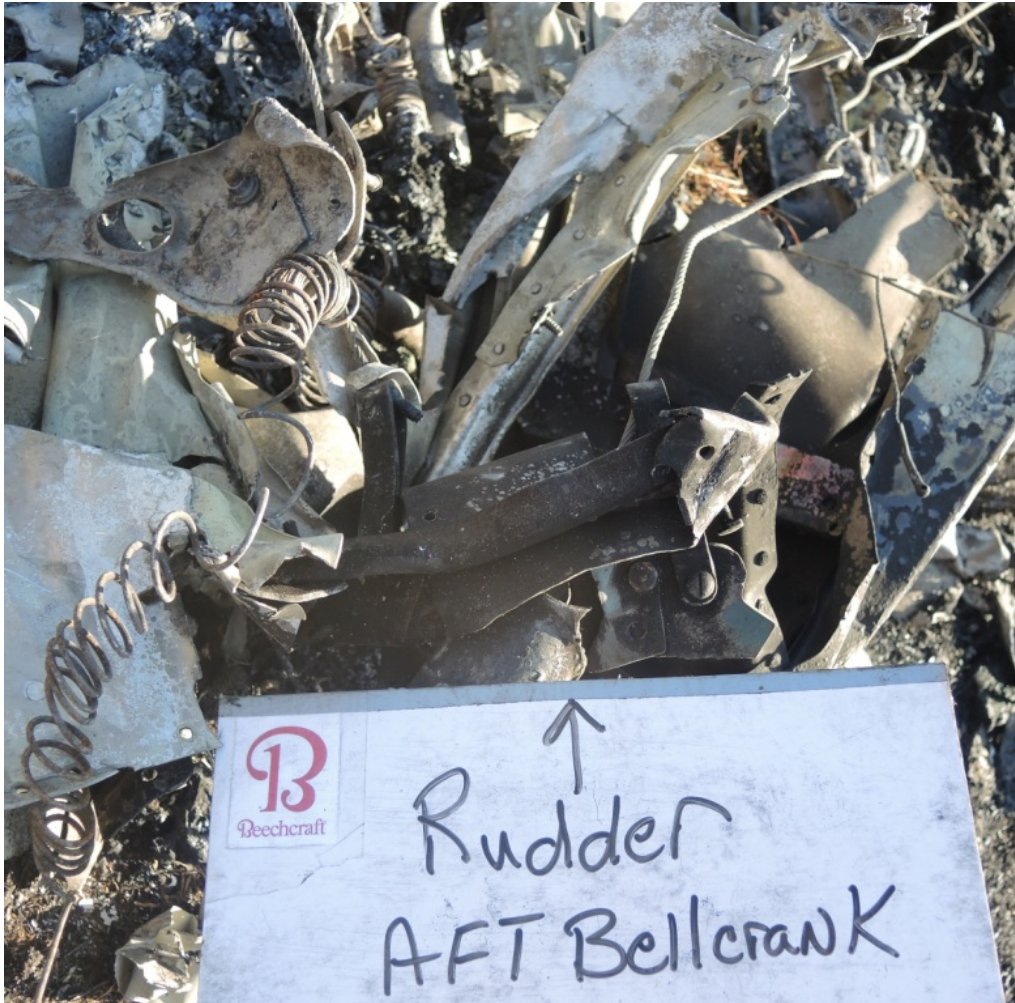
Figure 29 - Rudder Bellcrank

- The right rudder cable was continuous throughout its length
 - The left rudder cable exhibited a fracture separation consistent with tensile overload, about 3 feet forward of the rudder aft bellcrank
